HAMPDEN COUNTY REGISTRY OF DEEDS

DAMS FILE COLLECTION

BOOK D25 – 4 (U-Z)

Reports Section—Dams - Hampden County Massachusetts

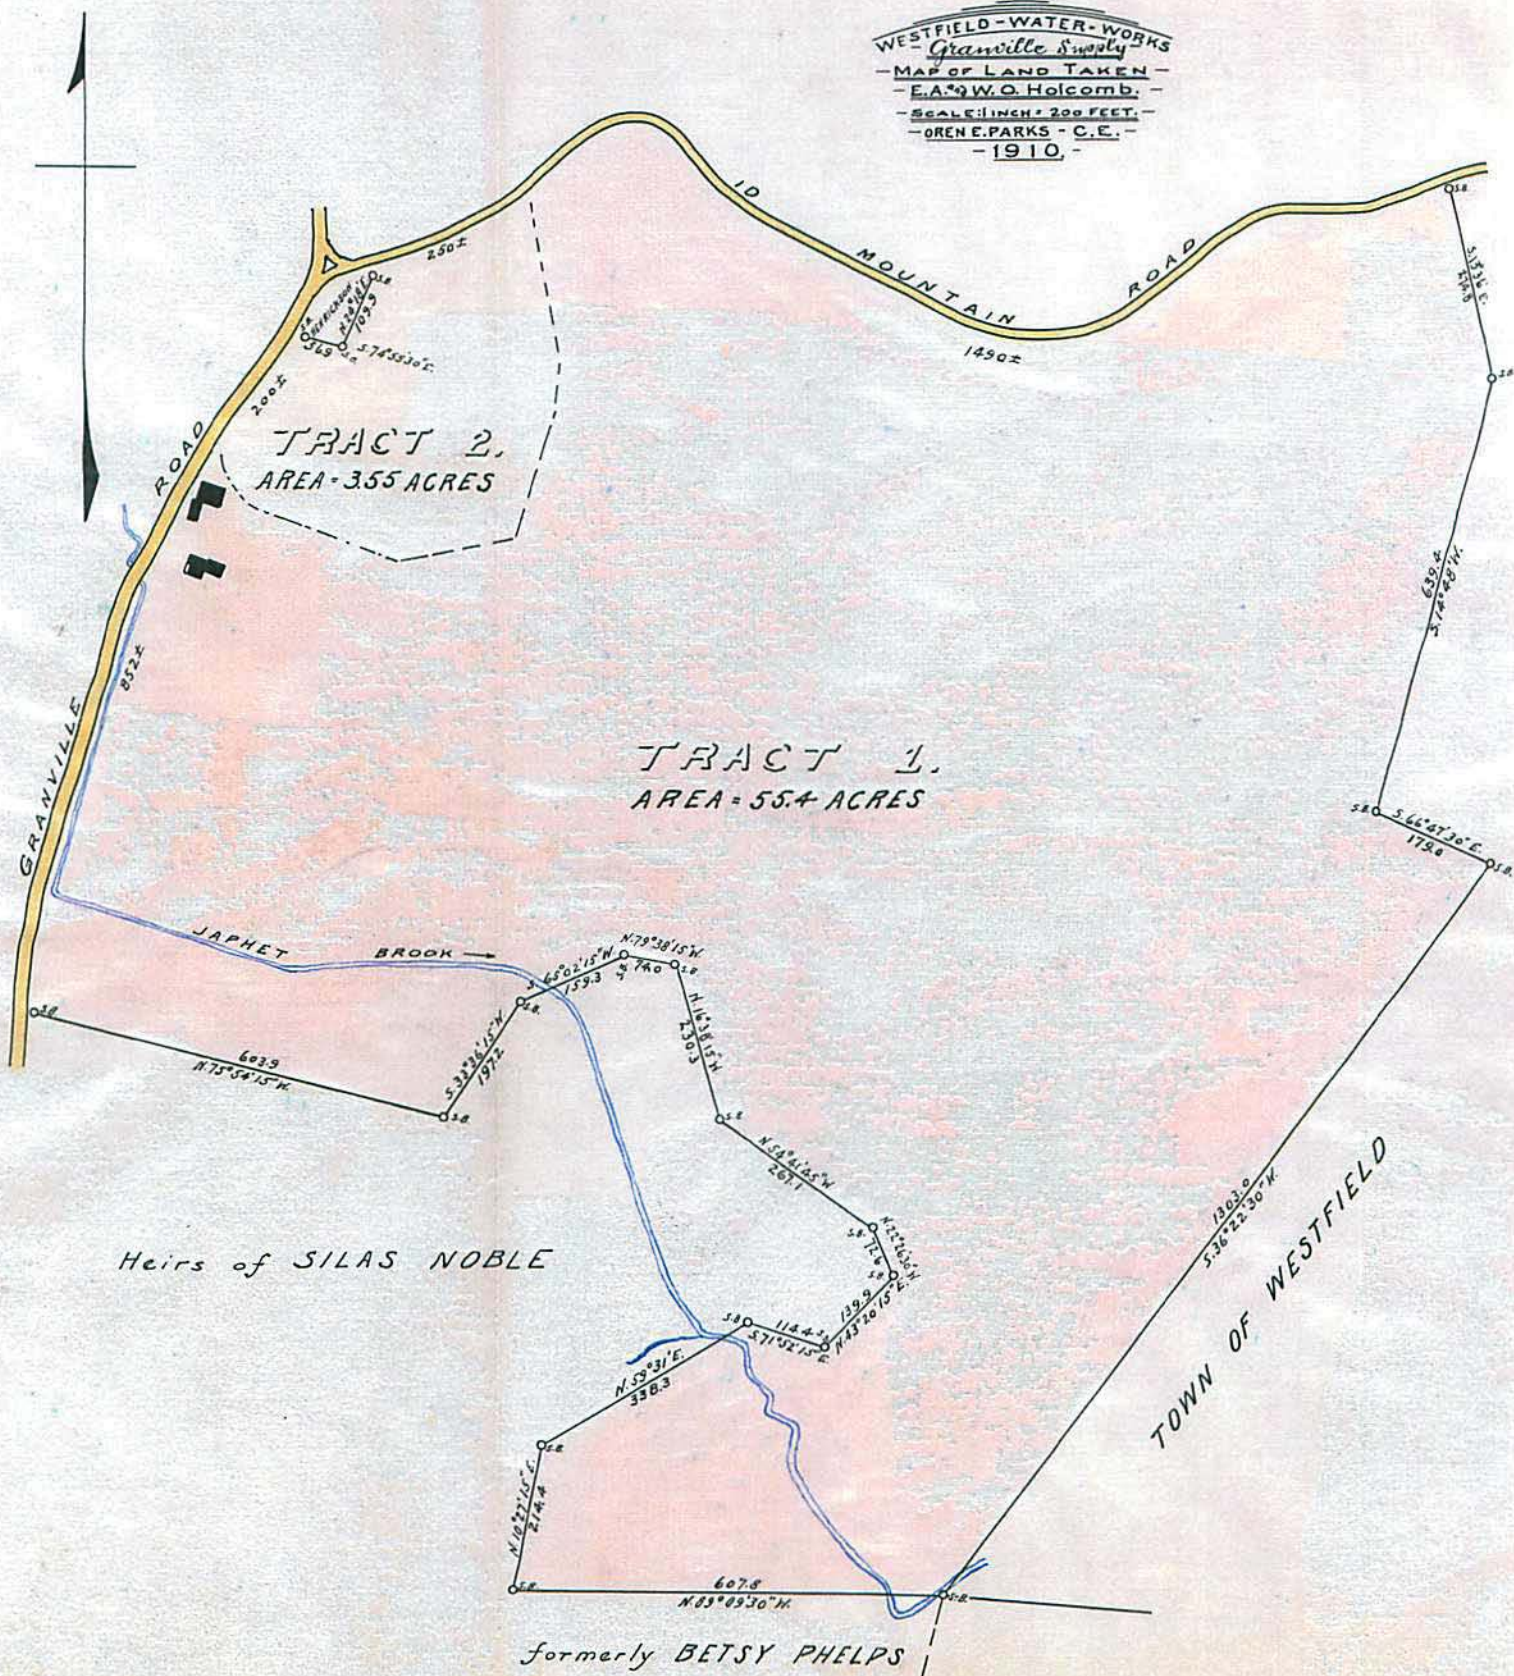
WESTFIELD-WATER-WORKS
Granville Supply
 - MAP OF LAND TAKEN -
 - E.A. & W.O. HOLCOMB. -
 - SCALE: 1 INCH = 200 FEET -
 - OREN E. PARKS - C.E. -
 - 1910 -

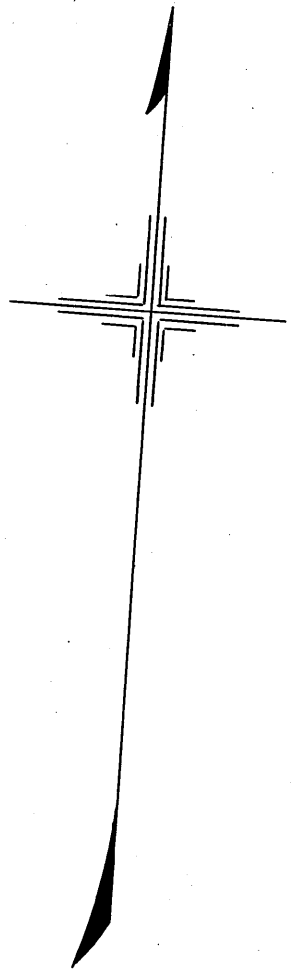
WESTFIELD-WATER-WORKS
Granville Supply
- MAP OF LAND TAKEN -
- Sarah E. Hollister -
- SCALE: 1 INCH = 200 FEET -
- J.L. Hyde - C.E. -
- 1912 -

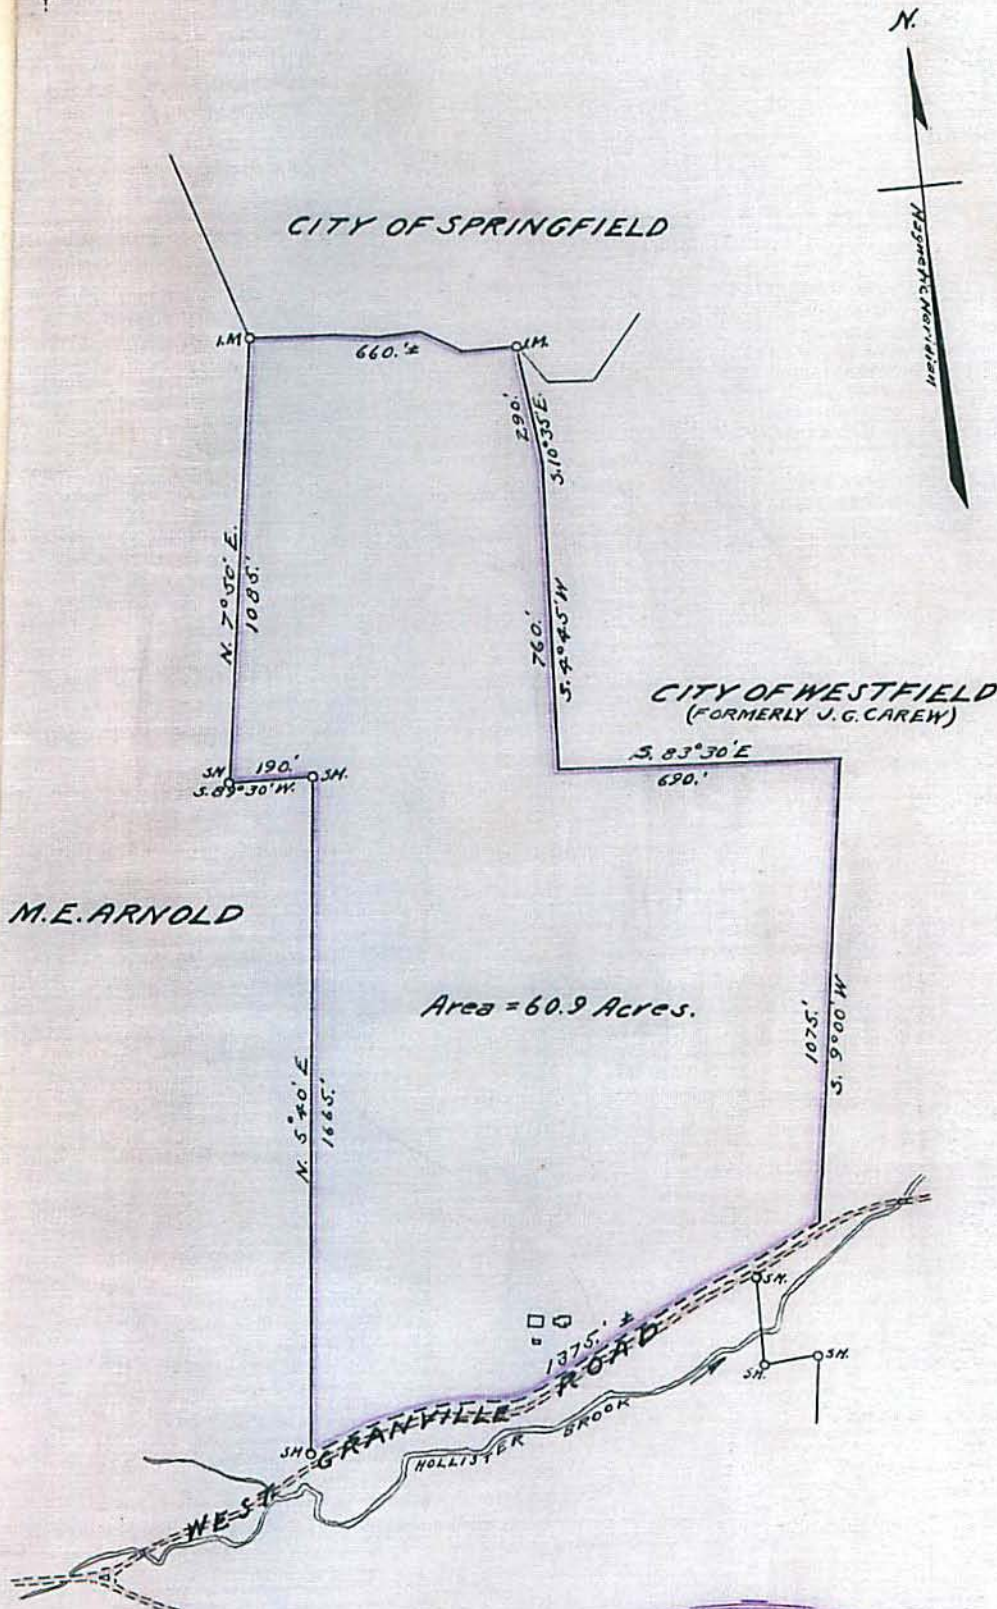
WESTFIELD WATER WORKS
- Granville Supply -
- MAP OF LAND TAKEN -
- A.E. & L.O. PECK -
- SCALE: 1 inch = 400 feet -
- A.L. PEABODY - Engr -
- 1922 -

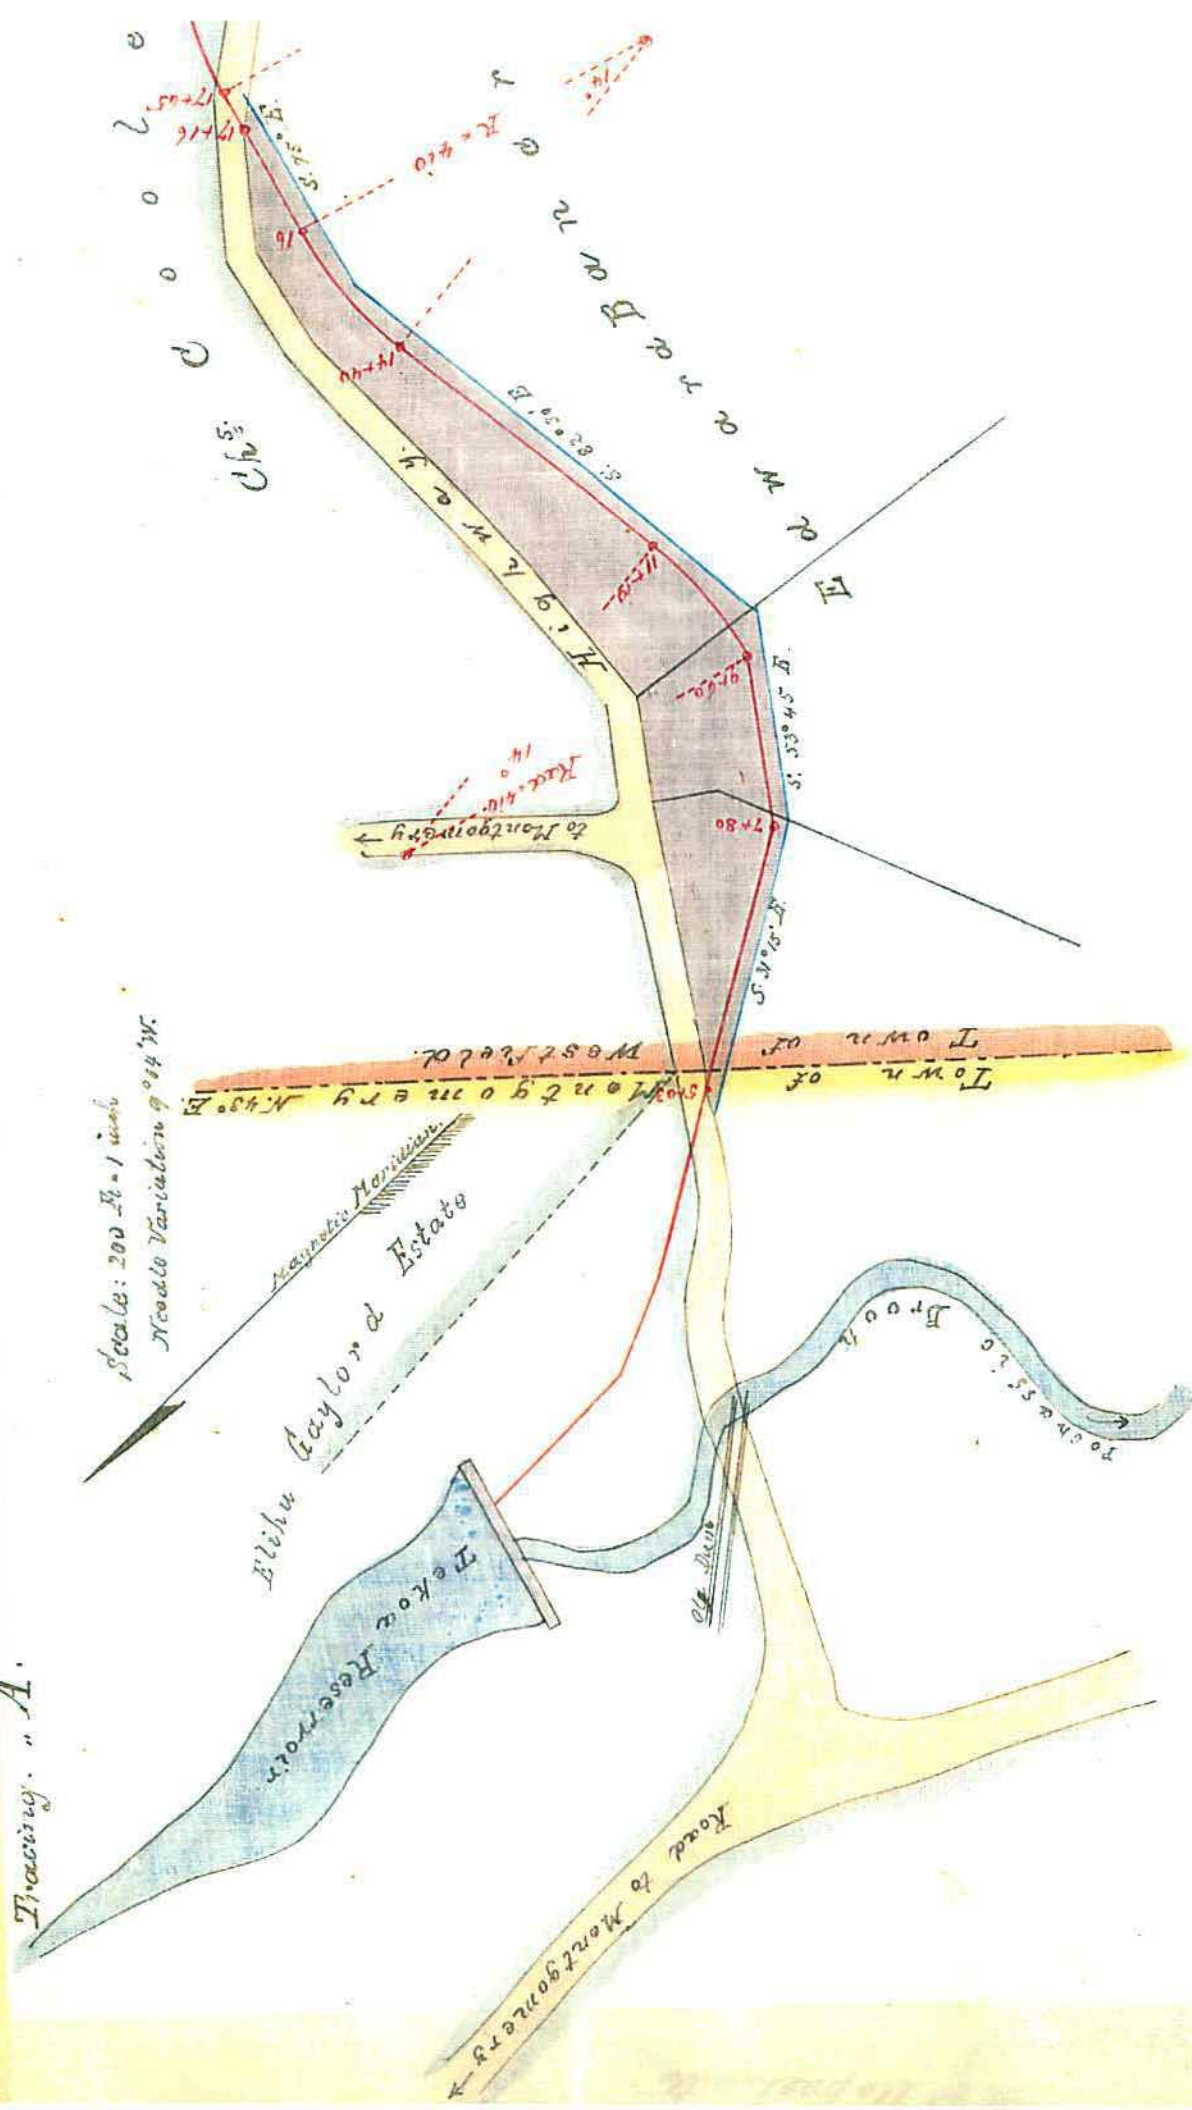
Scale: 200 ft = 1 inch
Needle Variation $9^{\circ} 14' W.$

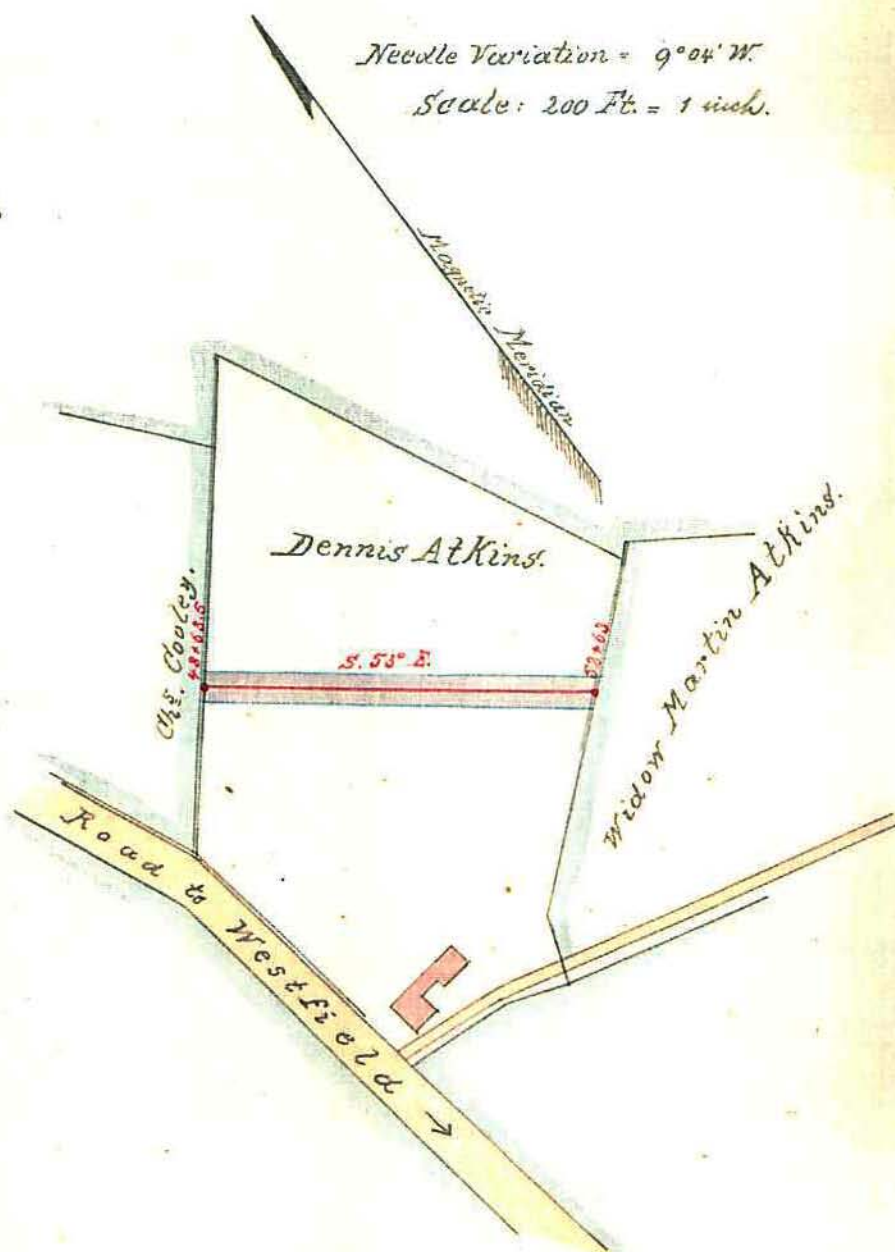
Tracing... C."

Commencing at a Stake and
Stone in division line between Charles Cooly^{sr} and Dennis
Atkins Sta. 48+63.5 as shown in tracing marked C. hereto
annexed and running S. 53. E. 600 feet to a Stake and Stone
Sta 52+⁶³~~63~~ in division line between Dennis Atkins and
Widow Martin Atkins,

The above description is for the centre
line of location, the width of land taken being one rod on
each side of said centreline, meaning to encompas all land
lying between said division lines and lines parallel with
and one rod right and one rod left of said centreline of
location containing forty-one rods (41 Rods) more or less.

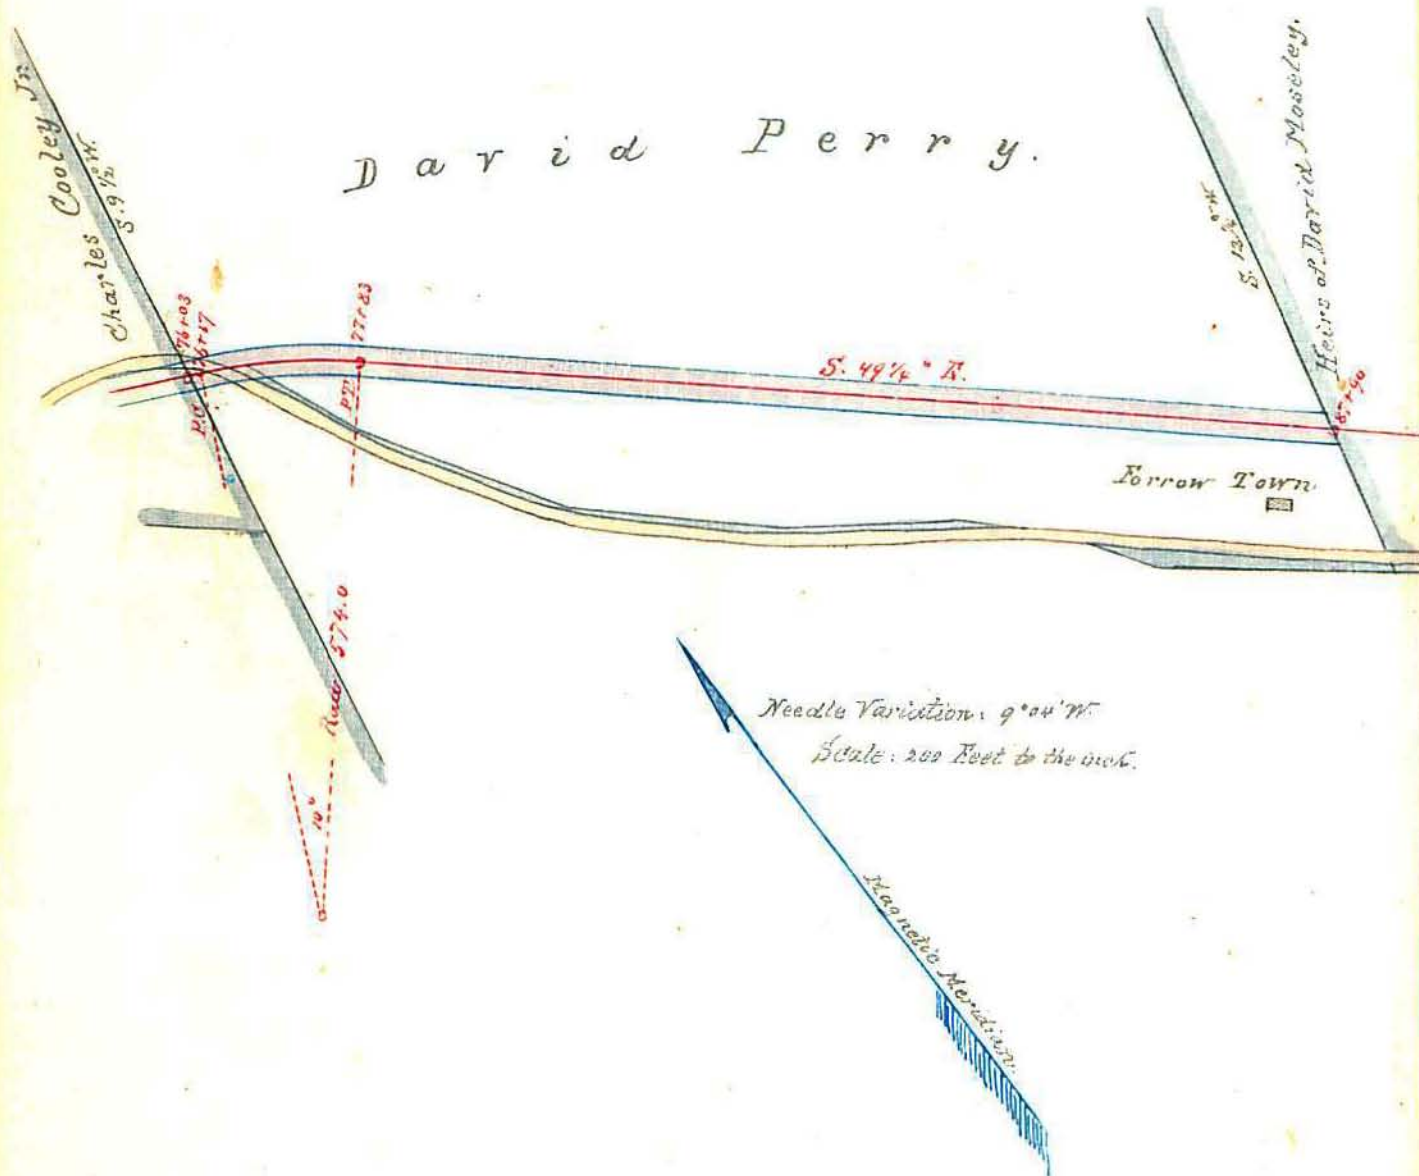
Tracing "G."

Commencing at a Stake and Stone in the division fence
between Charles Coolidge Jr and David Perry Sta. 76+03 as shown in
tracing marked. Thence to a corner and running S 66° E a distance
of 14 feet to a Stake and Stone at Sta. 76+17 the commencement of
a 10° curve (Radius 574.0) to the right or easterly, Thence on said curve
166 feet to Sta. 77+83 the end of said curve, Thence on tangent
course S 49 1/4° E 1007 feet to Sta. 87+90 a point in division fence be-
tween David Perry and Heirs of David Moseley,

The above description is for the centre line of location
the whole length on centre being 1187 feet. The width of land
taken being one rod on each side of said centre line meaning
to cover all land lying between the above described division
lines and lines parallel with, and one rod right and one
rod left of said centre line of location, containing one hundred
and forty-four rods (144 rods) more or less.

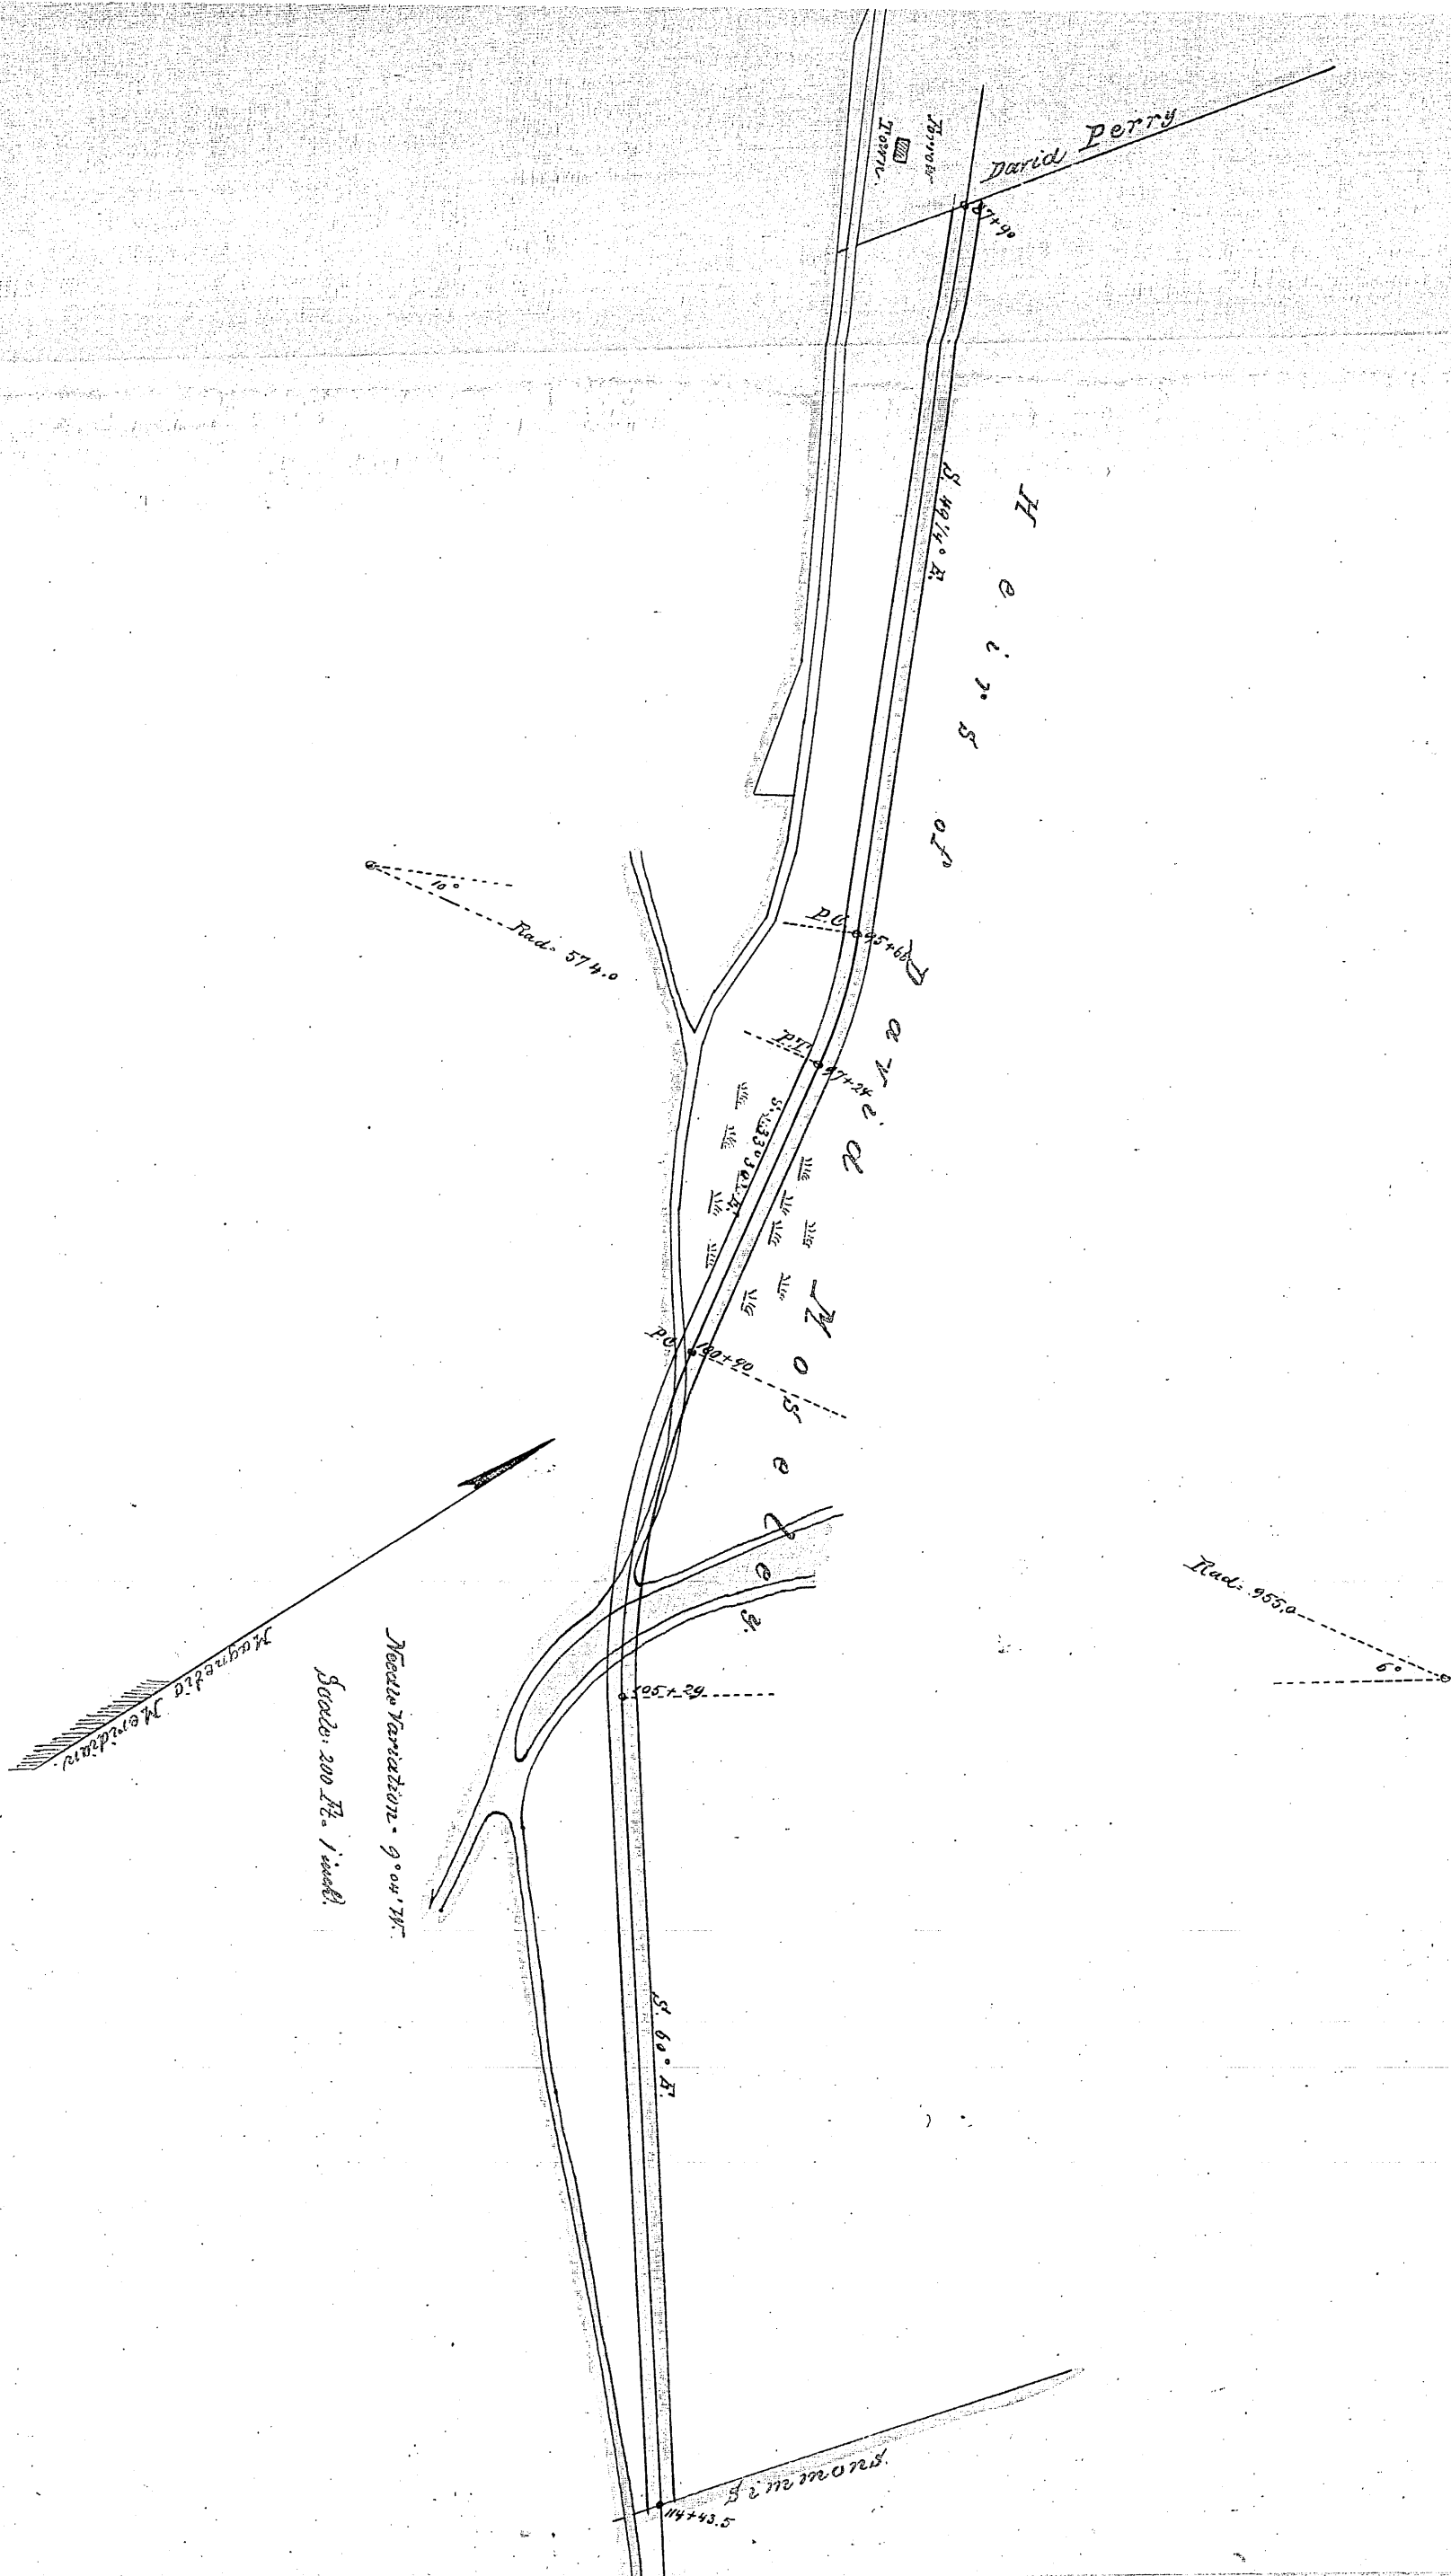
H

Commencing at a Stake and Stone in the division fence between David Perry and Hairs of David Mosely Sta. 87+90 as shown in tracing marked. H. Hunt annexed and running $S 49^{\circ} 14' E$ 776 feet to a Stake and Stone at Sta. 95+66 the commencement of a 10° curve (Radius 574') to the right or southerly, Thence on said curve a distance of 158 feet to Sta 97+24 the end of said curve, Thence on tangent course $S 33^{\circ} 30' E$ 366 feet to Stake and Stone at Sta 100+90 the commencement of a 6° curve (Radius 955 ft) to the left or northerly, Thence on said curve a distance of 439 ft to Sta. 105+29 the end of said curve, Thence on tangent course $S 66^{\circ} E$ 914.5 ft to Sta. 114+43.5 a point in division fence between Hairs of David Mosely and Simmons,

The above description is for the centerline of location the whole length on centre being 2653.5 feet; The width being one rod on each side of said centre line meaning to cover all land lying between the above described division lines and lines parallel with and one rod right and one rod left of said centre line of location containing two acres and two rods (2 Acres 2 Rods) more or less

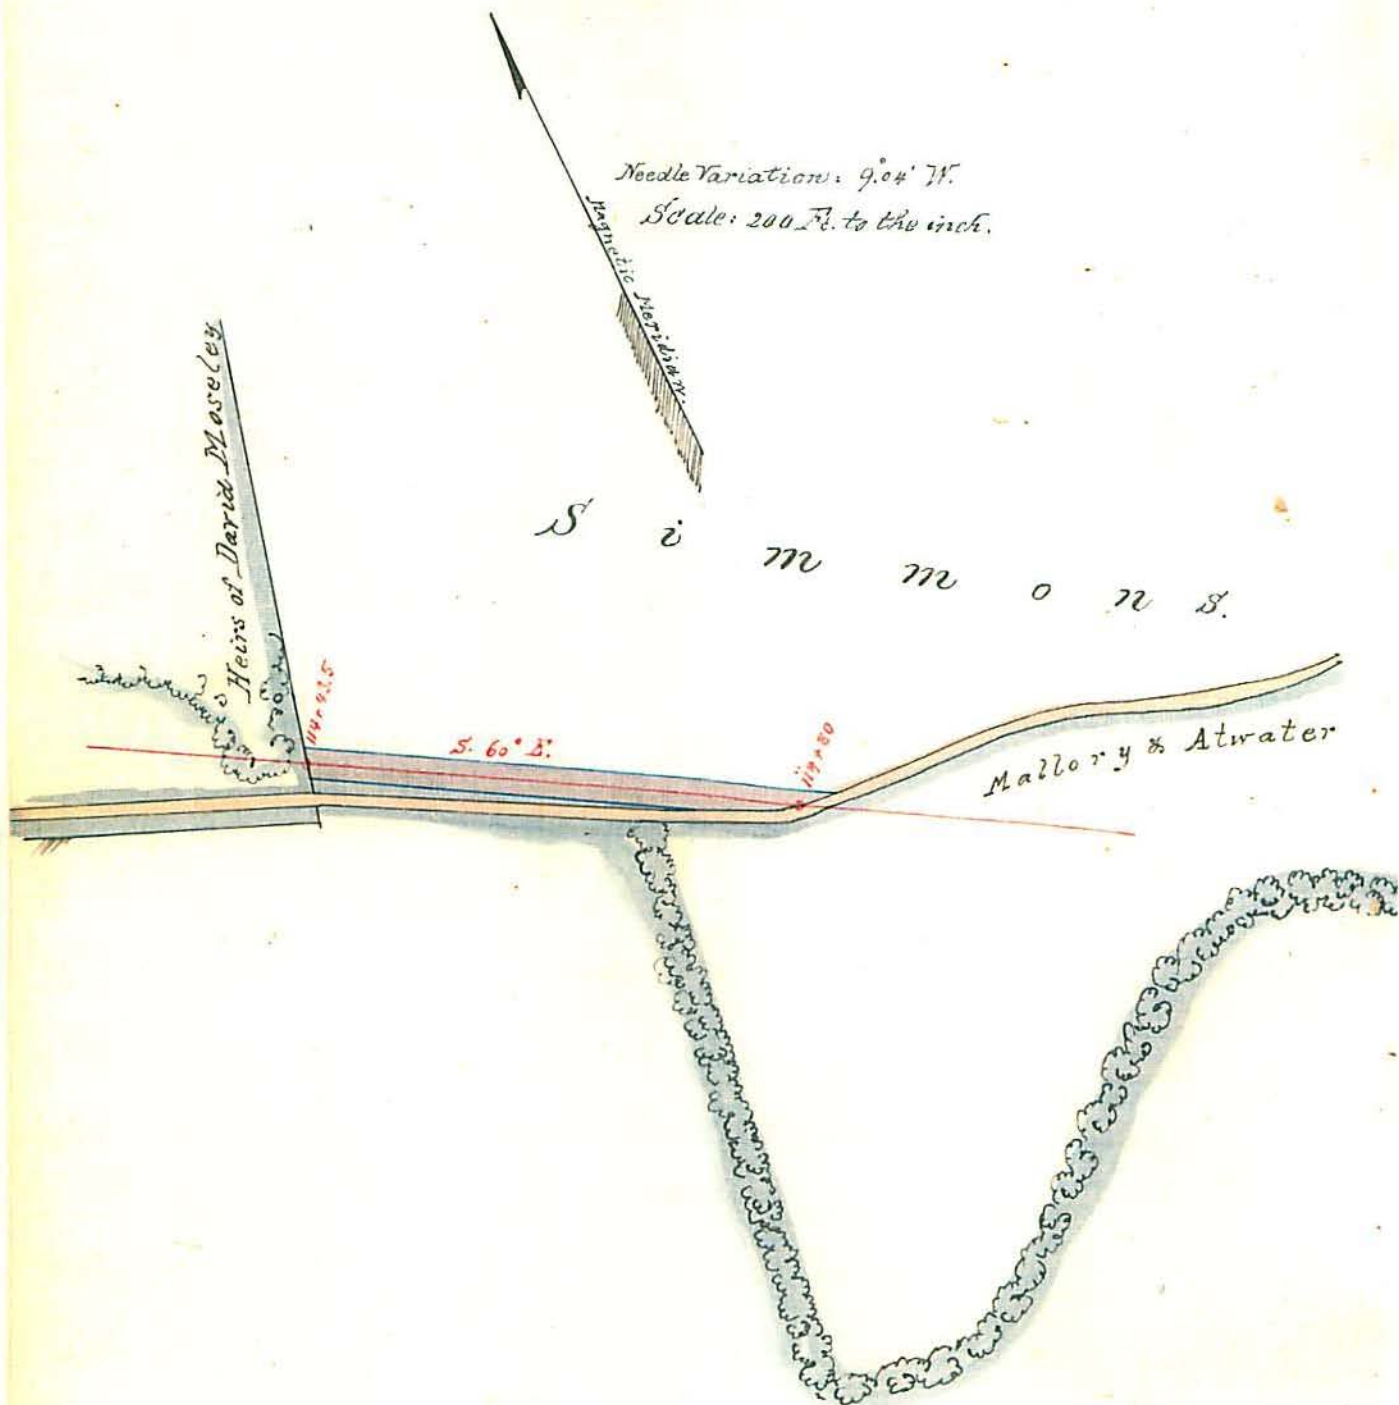
Tracing. " I. "

Commencing at Stake and Stone in division fence
between Heirs of David Mosely and Simmons Sta:
114+43.5 as shown in tracing marked, "I" here to accused and
running S 60° E 536.5 feet to Sta. 119+80 a point in division fence
between said Simmons and Mallory & Shwater,

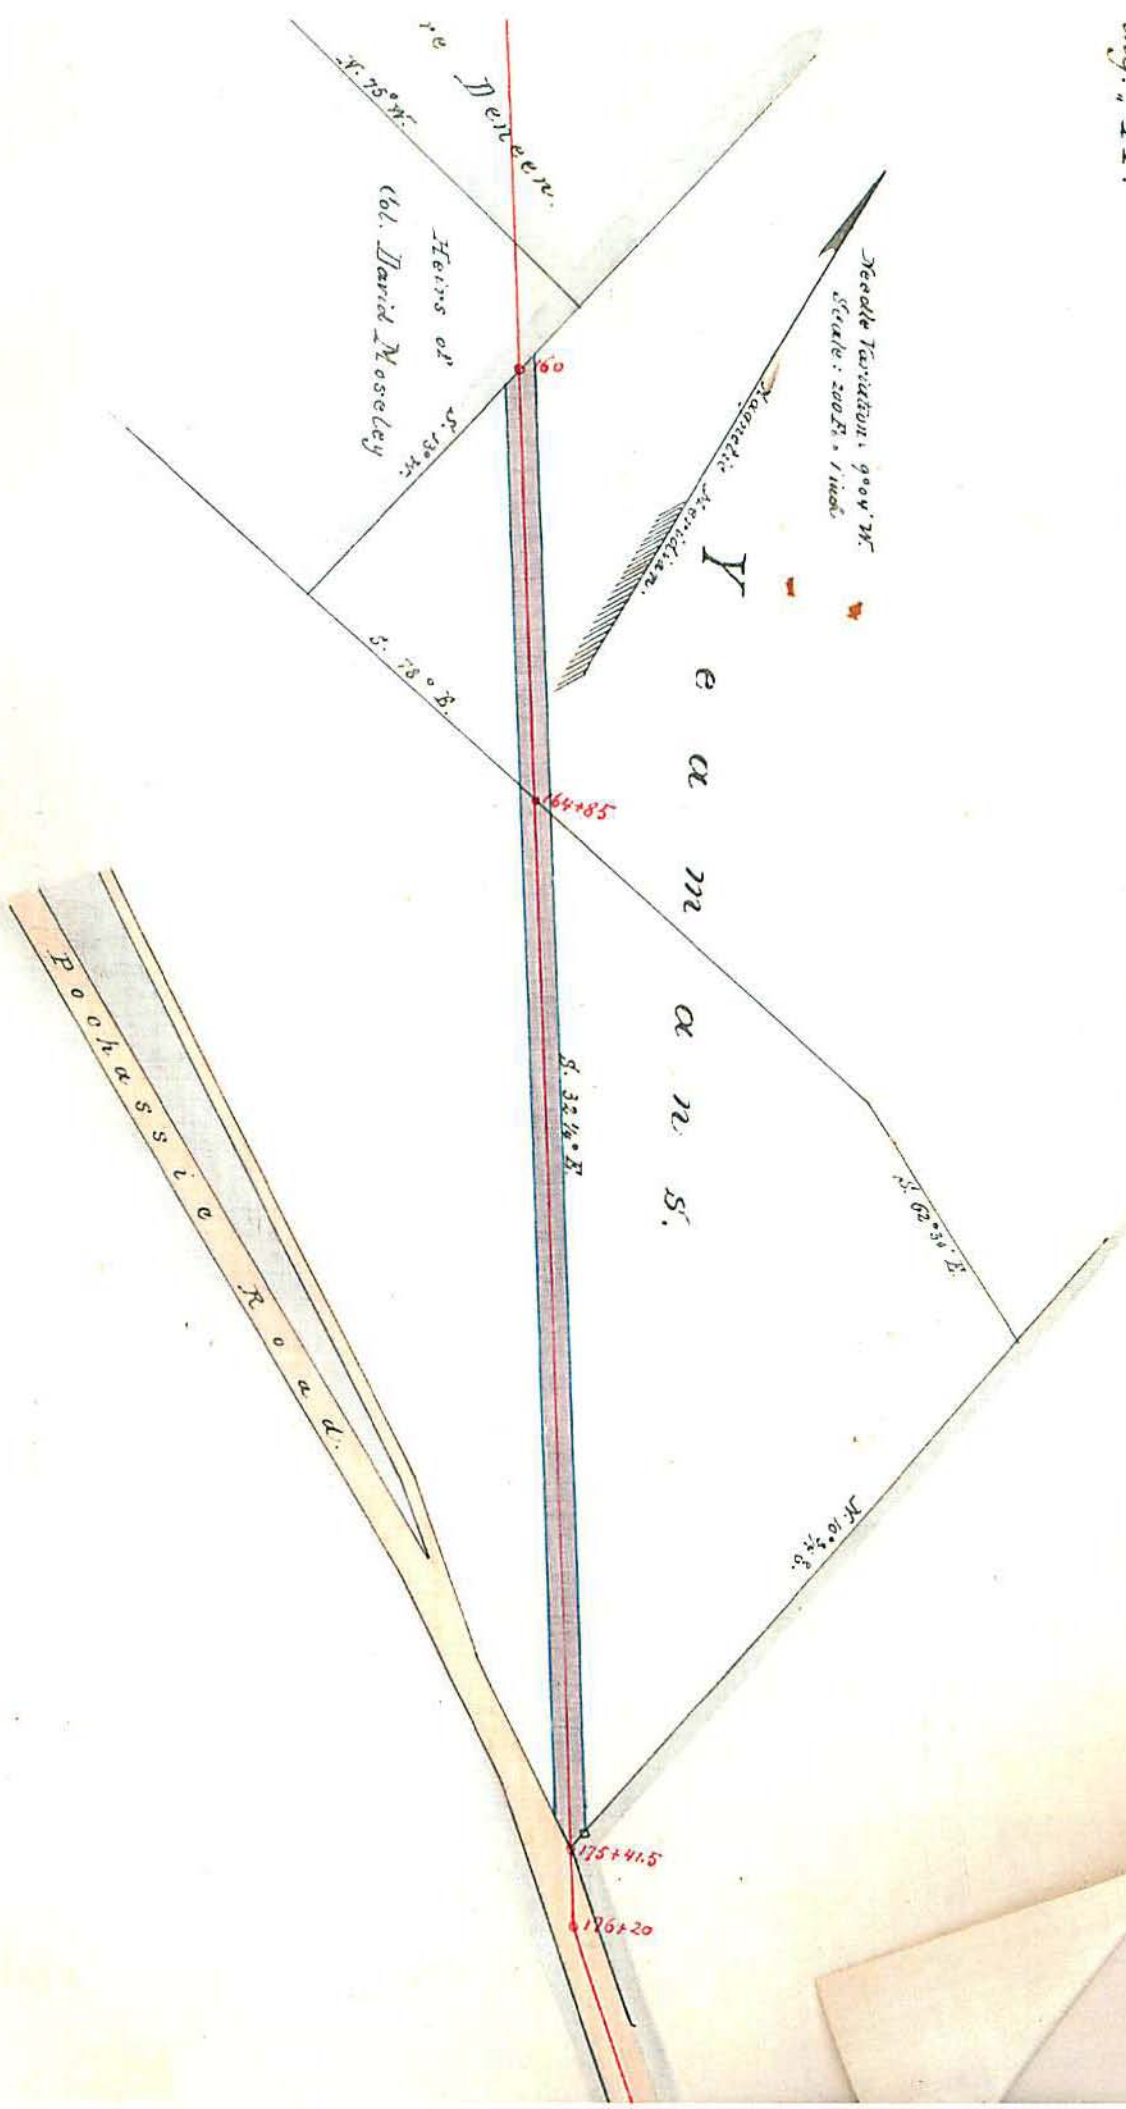
ing. M.

Commencing at a Stake and Stone in the division fence
between heirs of Col. David Mosely and Yamans
Sta. 160. as shown in tracing marked "M" ^{here} to be run and
running S $32\frac{1}{4}^{\circ}$ E 1541.5 feet to a Stake and Stone at Sta. 175 + 41.5 a
point in the northerly line of Pochassie Road.

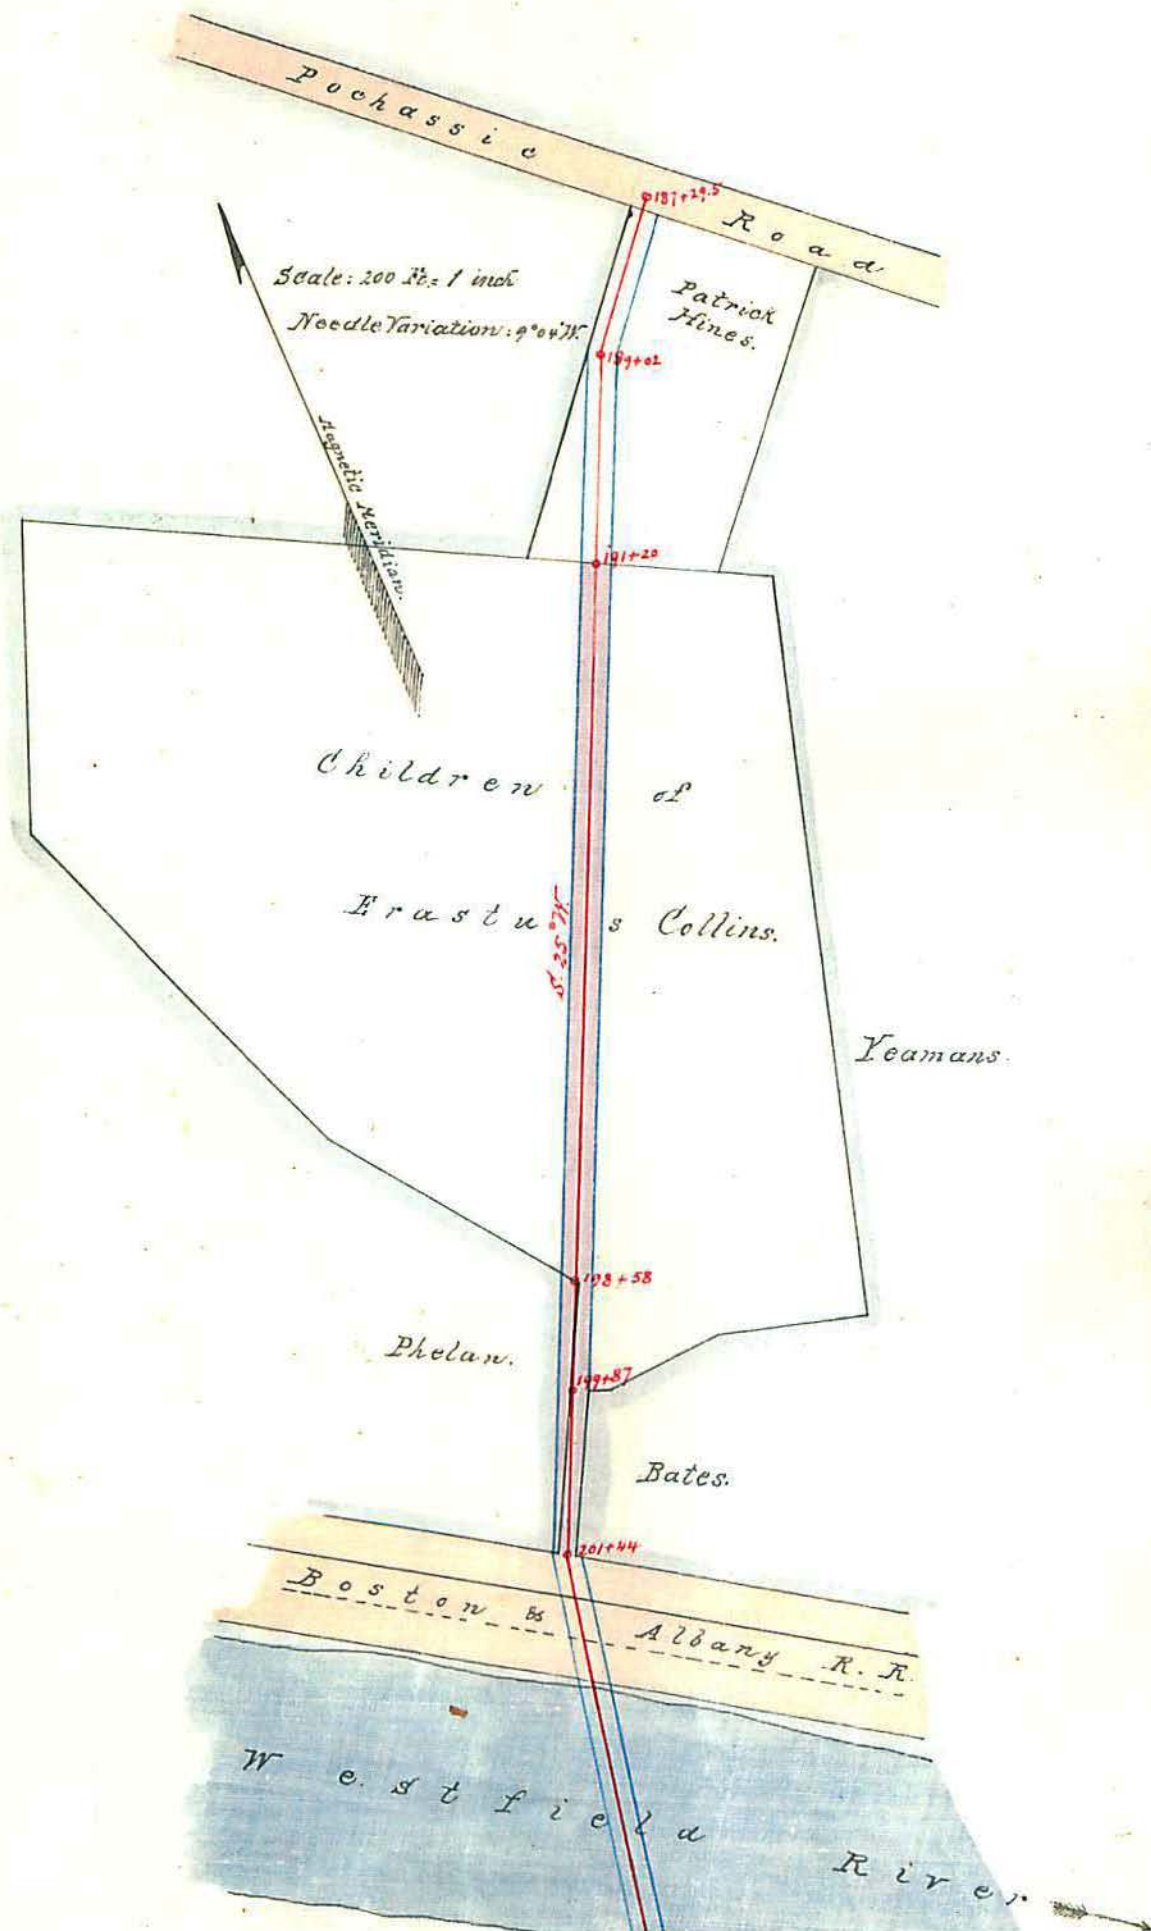
Tracing, O."

Commencing at a Stake and Stone in division line between Patrick Hines and said Collins, Children at Sta. 191+20 as shown on tracing marked "O" here to accused and running S 25° W about 1074 feet to a point in the northerly line of Pochassic St. and 8 1/2 feet westerly of Bates S.W. corner, the above description is for the center line of location, the width of land taken being one rod on each side of said center line excepting from Sta 199+87 a point at right angles to and one rod westerly of Bates S.W. corner to Pochassic St., the land taken is bounded on the left or easterly by Bates west line the width on the right or westerly being one rod, meaning to cover all land above described supposed to belong to Collins Children not covered by the description of land taken from John and Elisha Philau, containing 106 Rods more or less,
